# Affected Culverts for Proposed Tree Removal

Level 1 concern "applies to a tree that is likely to expereince failure under normal weather conditions and impact the canal in the event of failure"  
(normal weather conditions are winds under 35mph) (condition is already considered in the level of concern rankings)

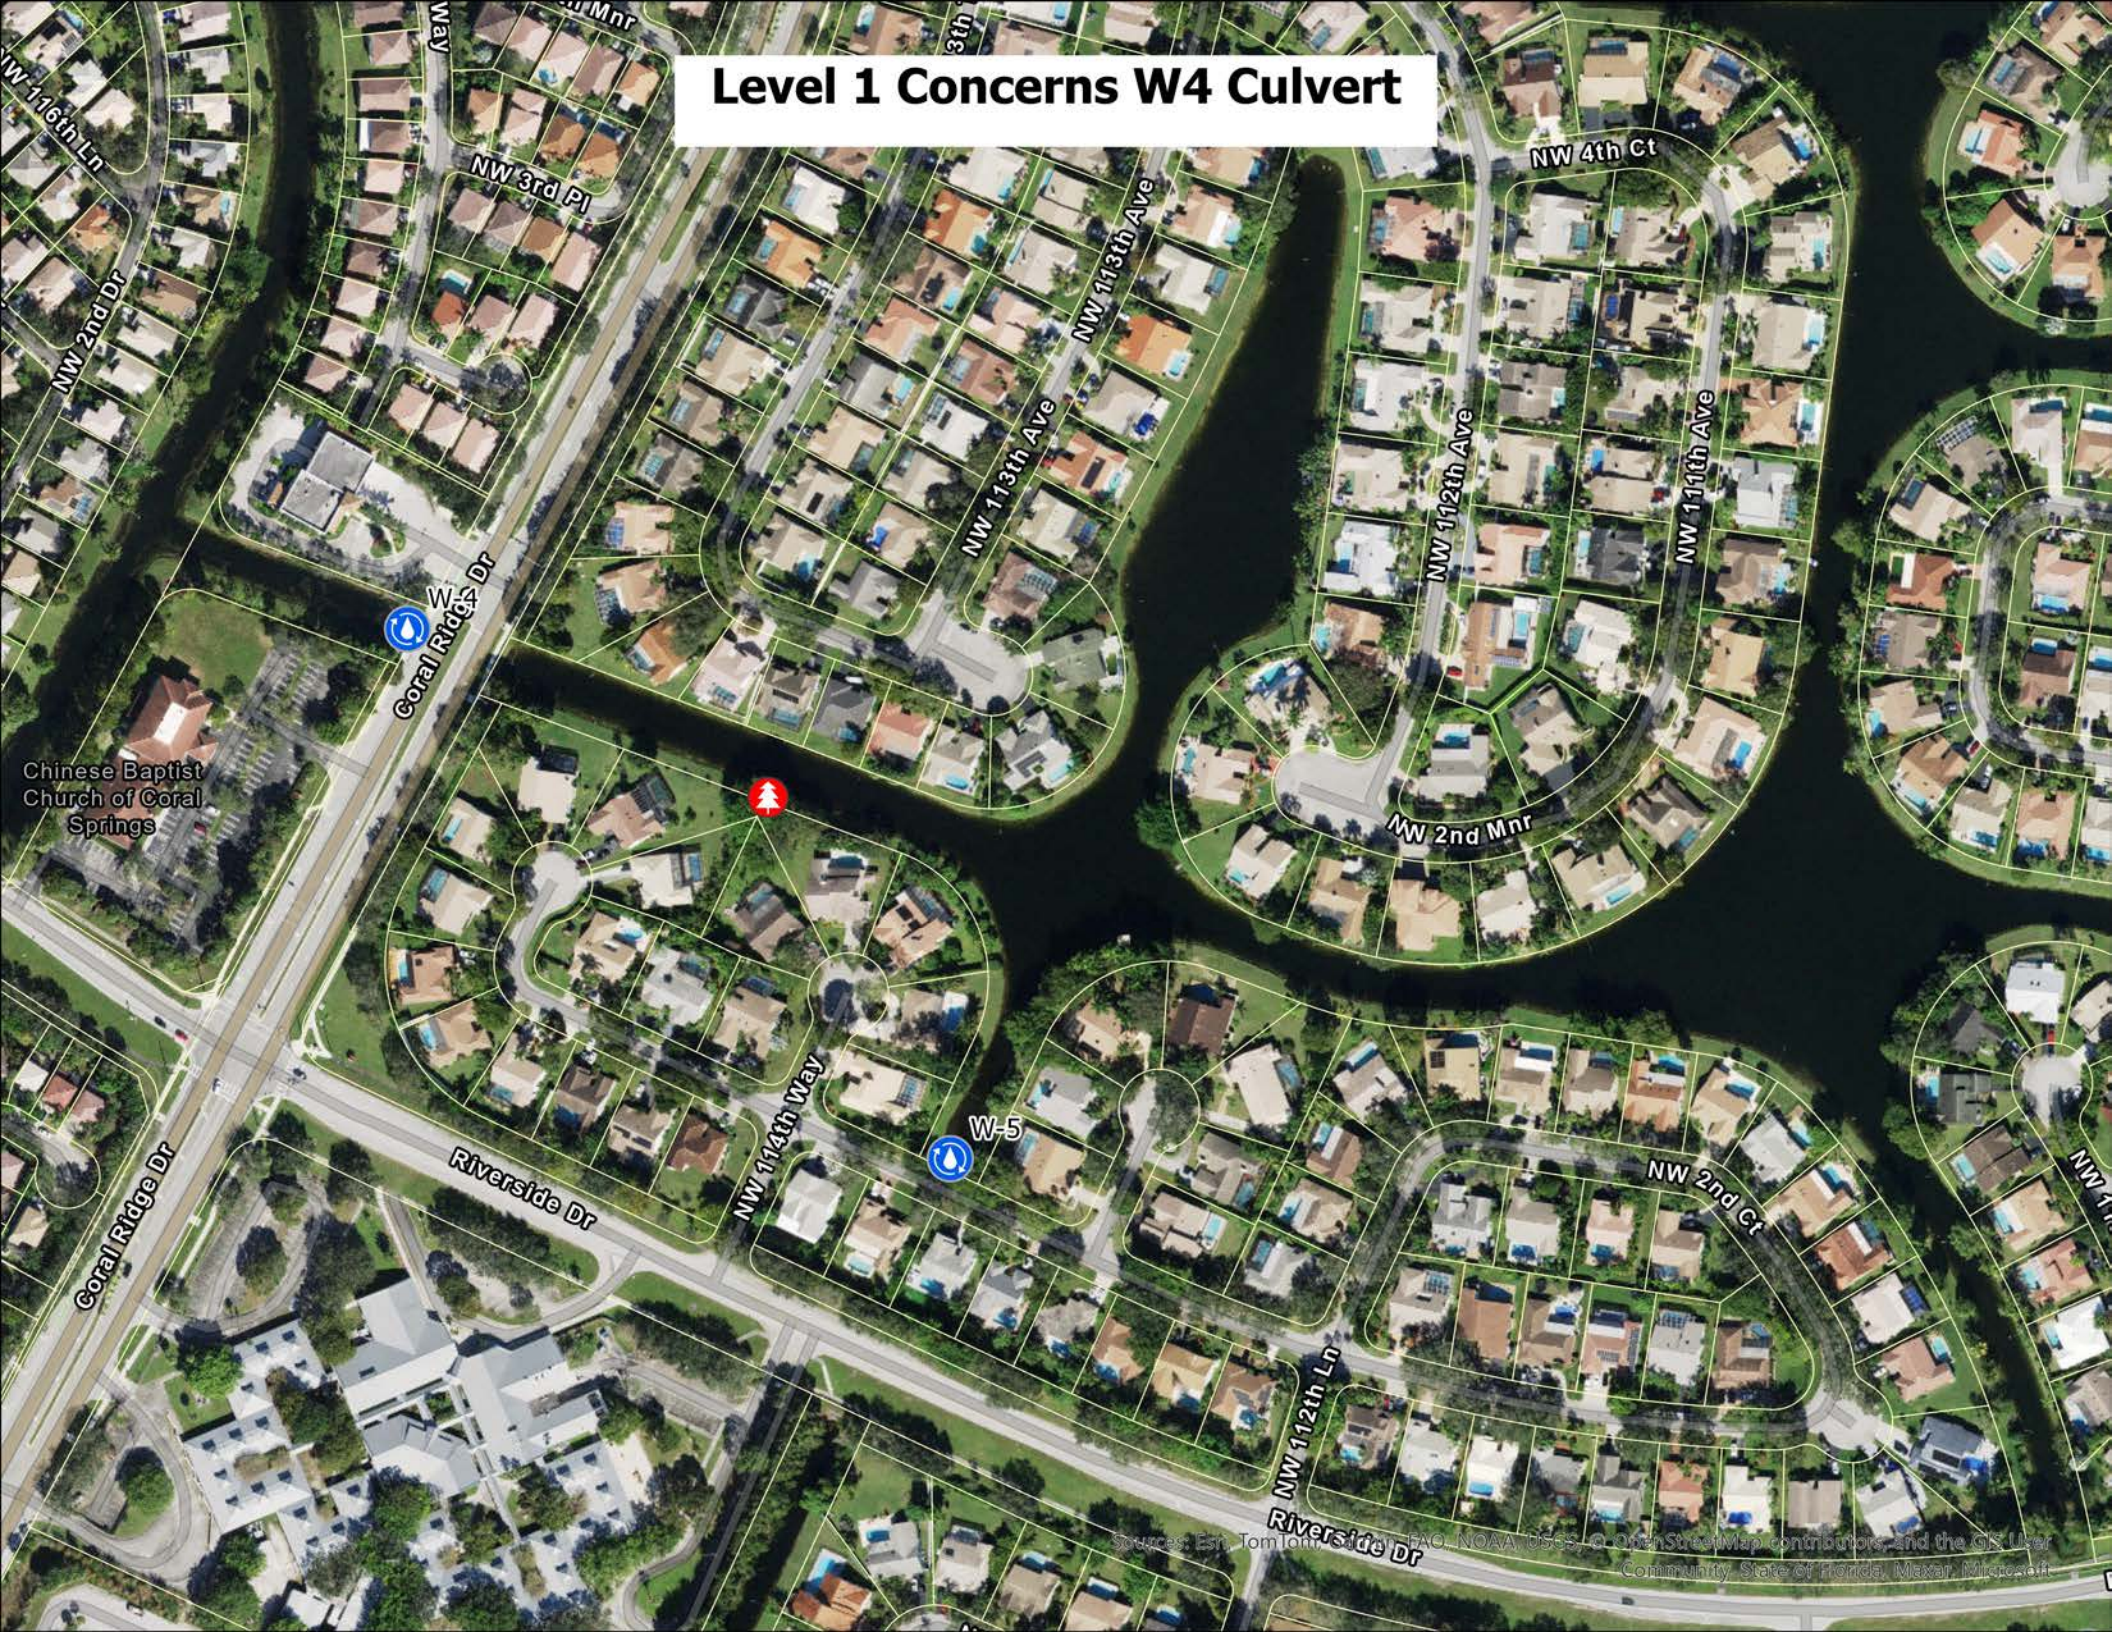
# Level 1 Concerns W4 Culvert

| Species | Condition | Native | Invasive | Non-Native Desirable | Non-Native Invasvie | Shrub | Height ft) | Diameter | Canopy Size | Address |
|---|---|---|---|---|---|---|---|---|---|---|
| Ficus Nitida | Fair | | | | x | | 49 | 80 | 100x100 | 176 NW 114th |
